AMMRC TR 85-16

DEVELOPMENT OF A NITRIDE DISPERSION STRENGTHENED (NDS)
METALLIC ALLOY FOR HIGH-TEMPERATURE RECUPERATORS

June 1985

L. E. KINDLIMANN
AiResearch Manufacturing Company
2525 W. 190th Street
Torrance, California 90509

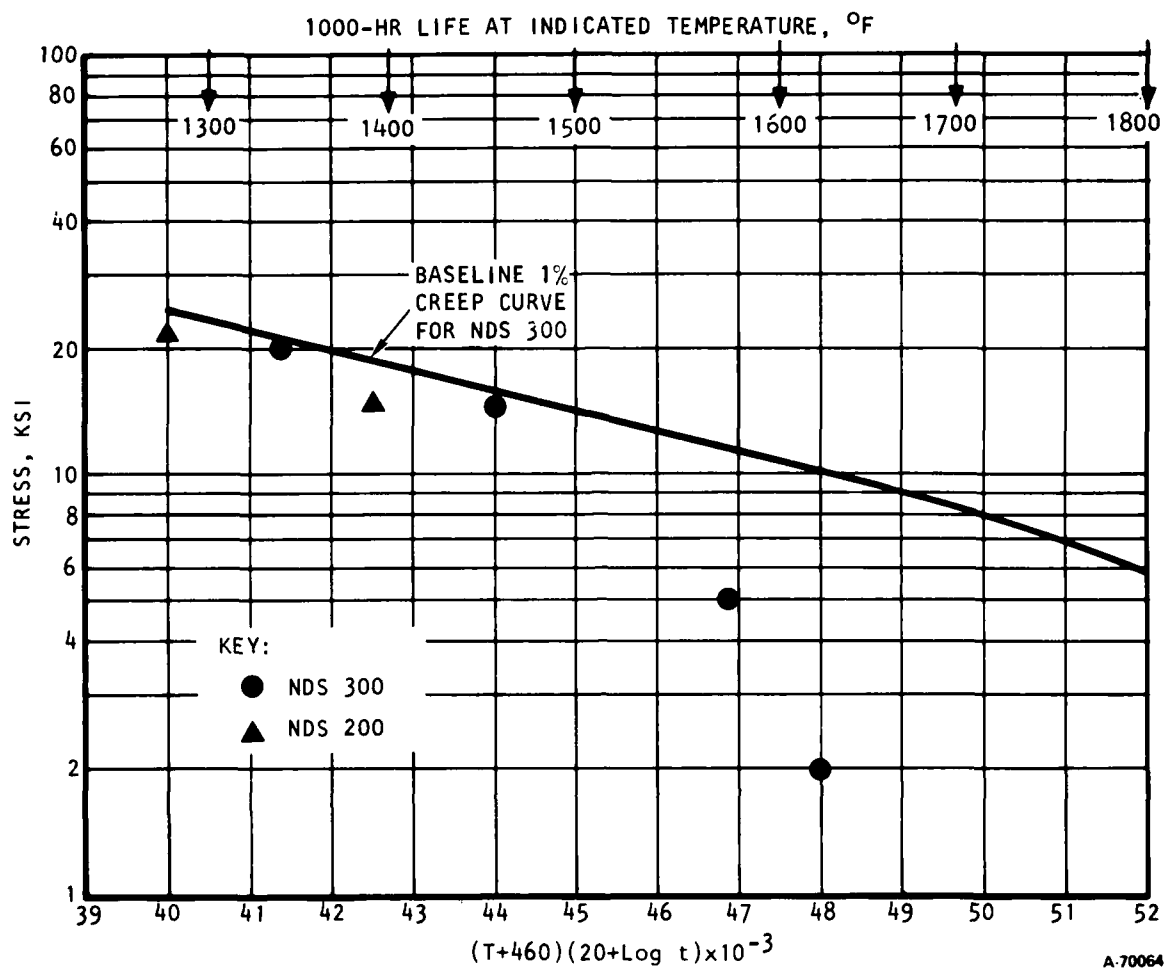
Figure 2-19. Master Plot Comparing 1-Percent Creep Behavior of NDS Alloys after Aluminizing to NDS 300 Baseline Curve

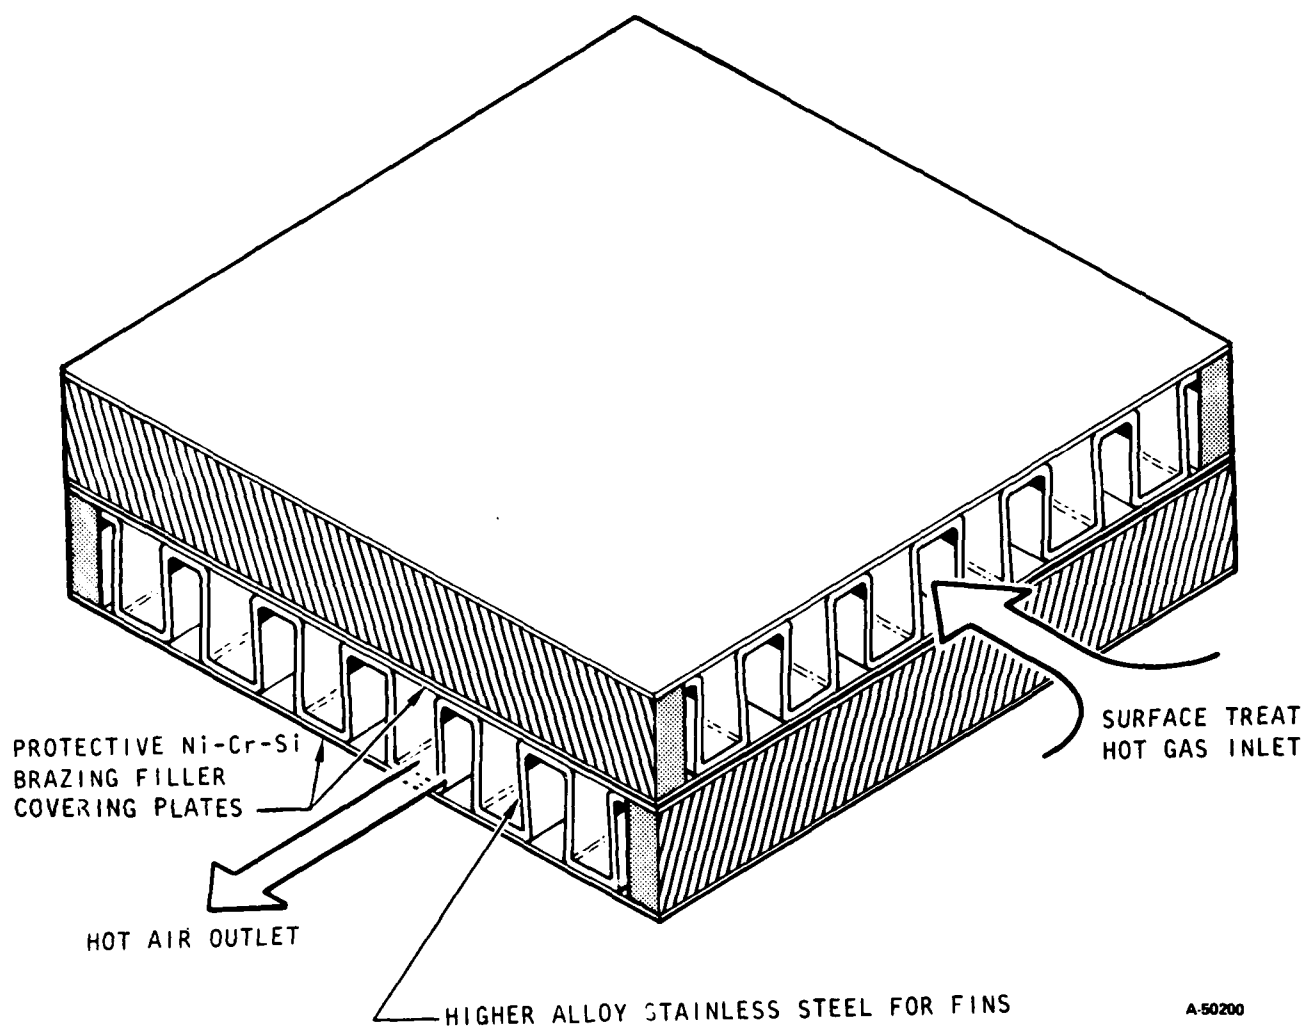
Figure 2-20. Options for Achieving Environmental Protection, Singly or in Combinations

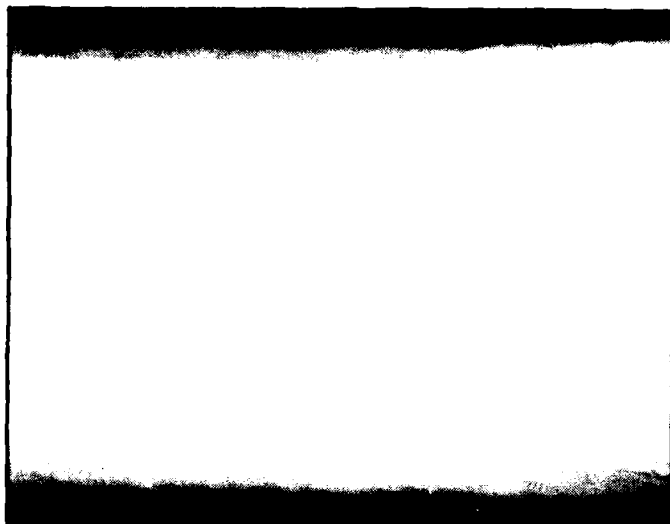
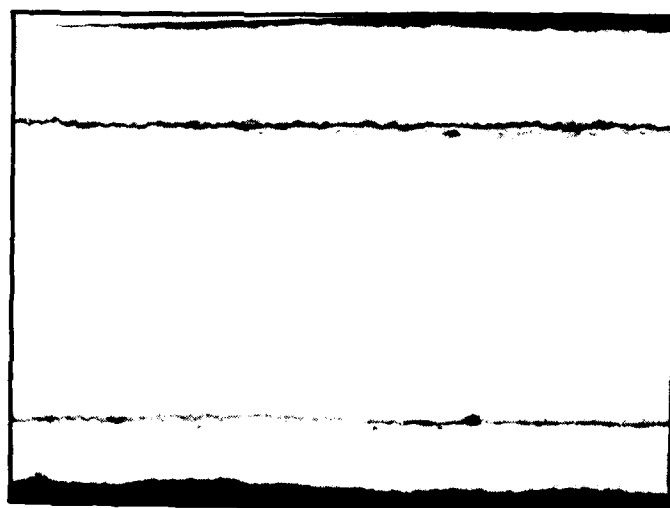
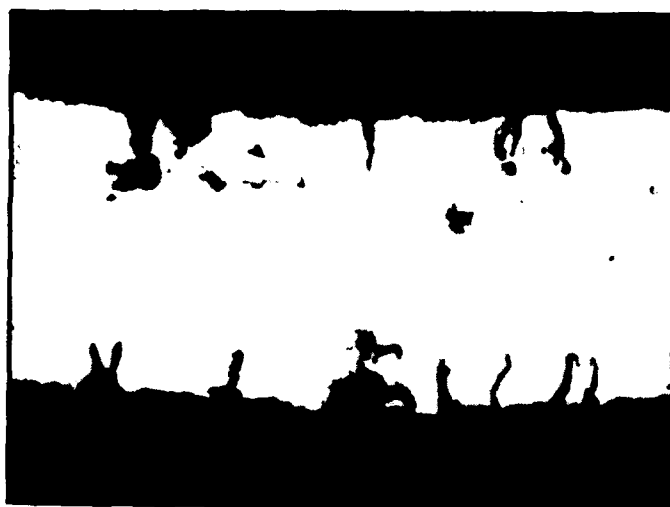
a. NDS 300 CONTROL
701 HR AT 1600°F

b. NDS 300 COATED
WITH AMI 100
701 HR AT 1800°F

c. NDS 300 CHROMIZED
BY ORIGINAL VENDOR
(SECOND TRIAL)
AS RECEIVED.
SAMPLE PITTED WHEN
ETCHED TO SHOW
CHROMIZED LAYER

Figure 2-21. Representative Micrographs of Cyclic
Oxidation Test Specimens--See Table 2-29
(Magnification, 200X)

d. NDS 300 WITH
AMI 100 OVERLAY,
ALUMINIZED BY
ALTERNATE VENDOR,
AS RECEIVED

e. NDS 300 WITH
AMI 100 OVERLAY,
ALUMINIZED AS
IN d. ABOVE.
701 HR AT 1600°F

f. INCOLOY 800H,
ALUMINIZED AS
ABOVE FOR NDS 300,
922 HR AT 1800°F

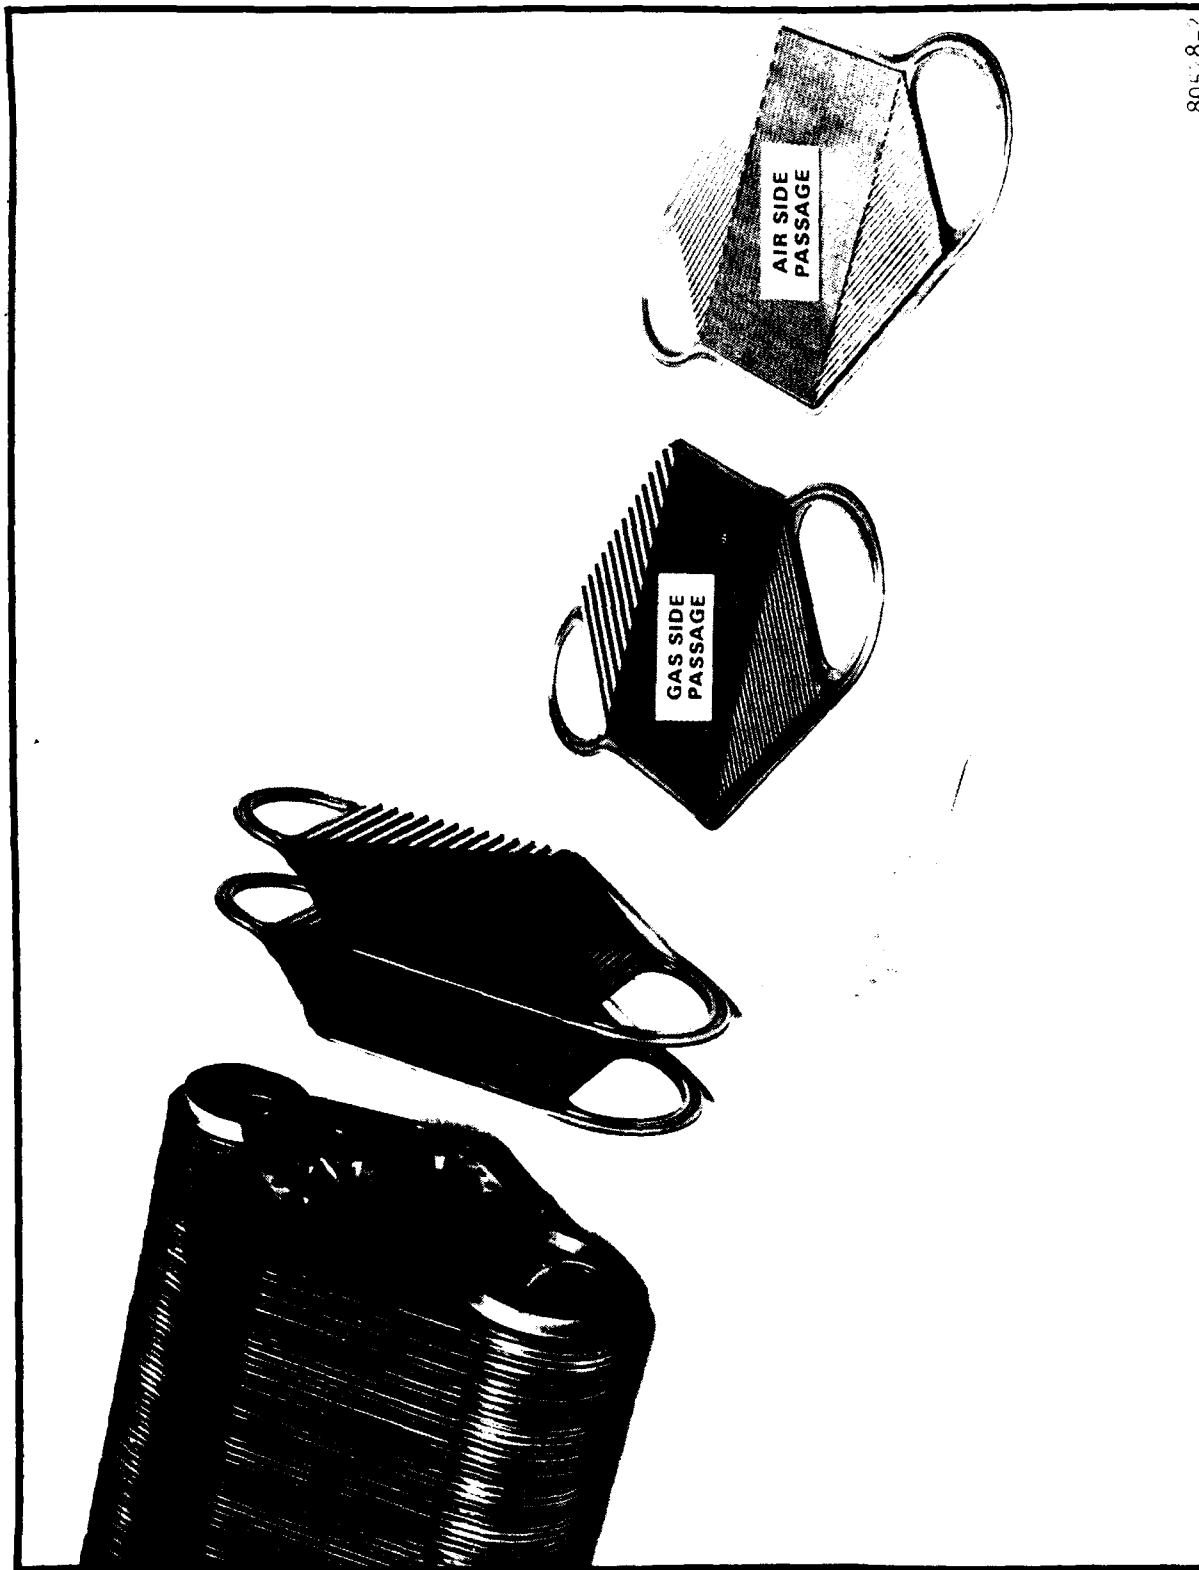
Figure 2-22. Example of Possible Forming Requirements Associated with Recuperator Fabrication

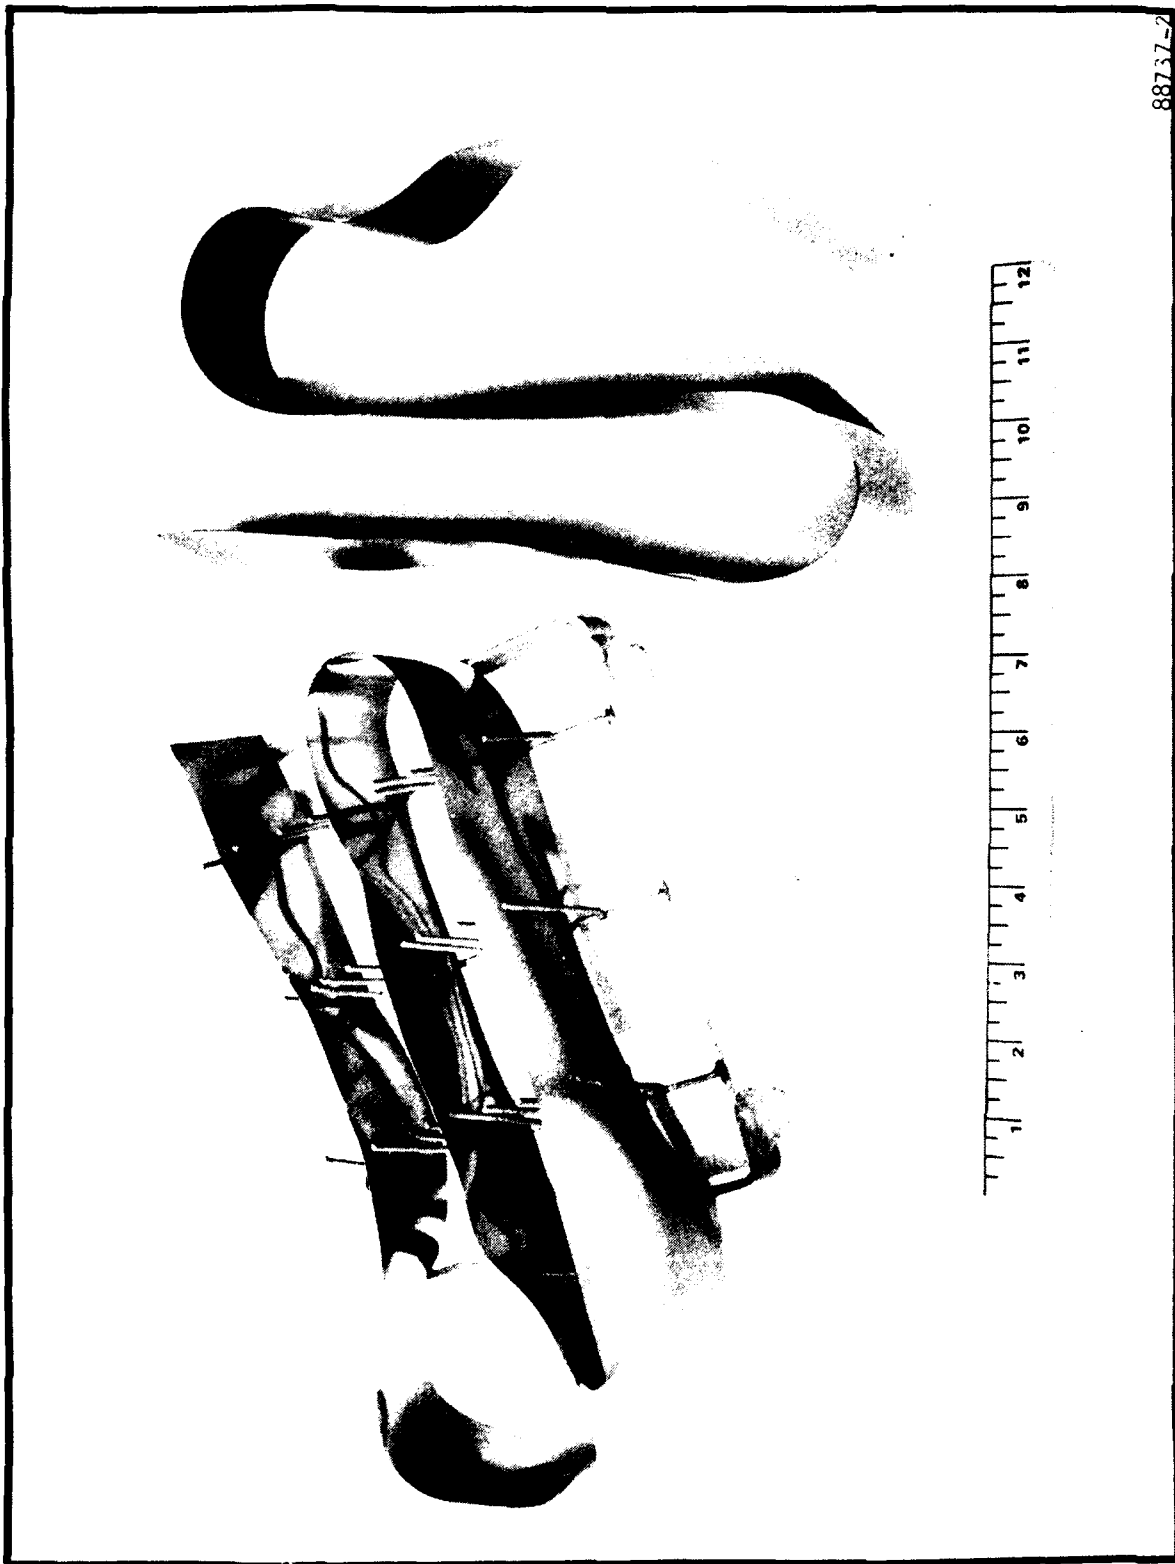
Figure 2-24. Rack Used for Nitriding 36-in.-Long Strip

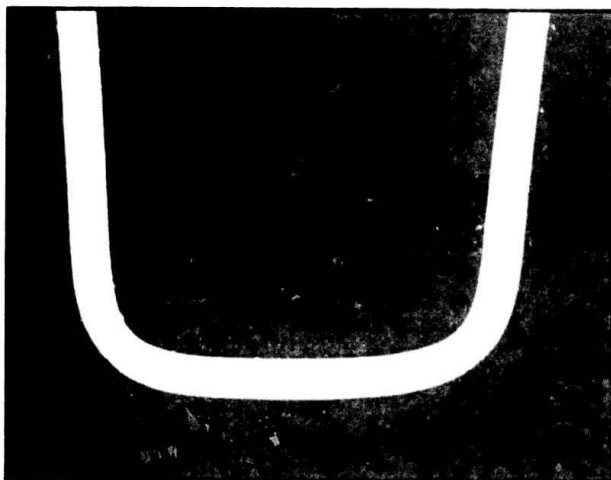
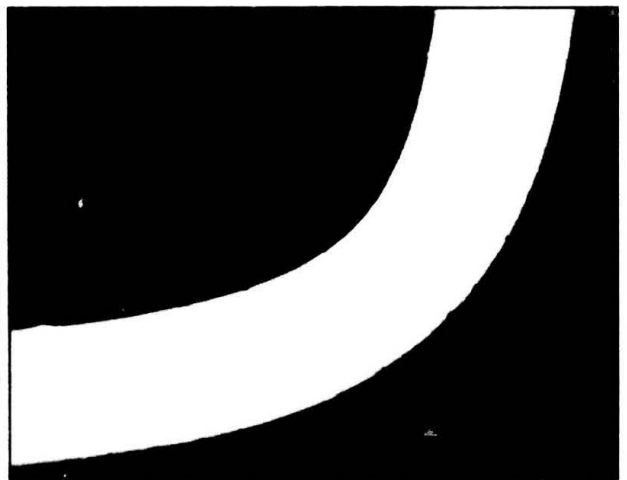
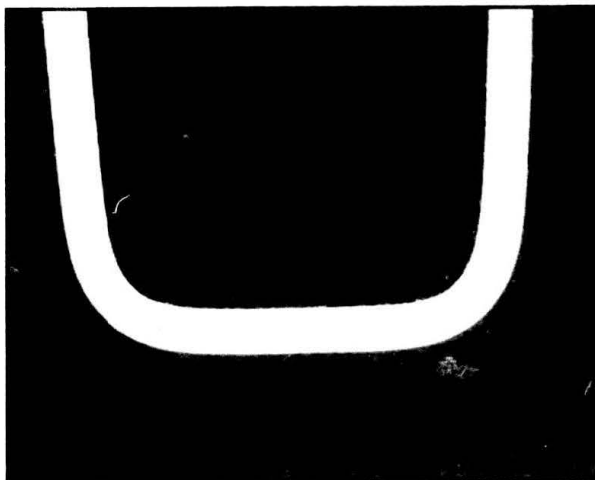
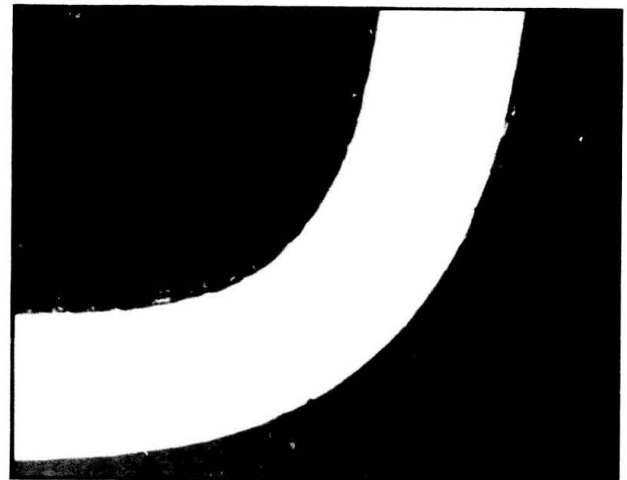
a. FULLY NITRIDED

b. INCOMPLETE NITRIDING

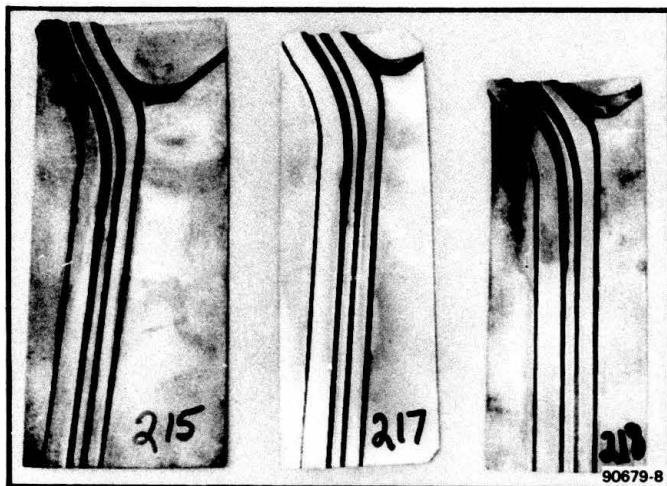
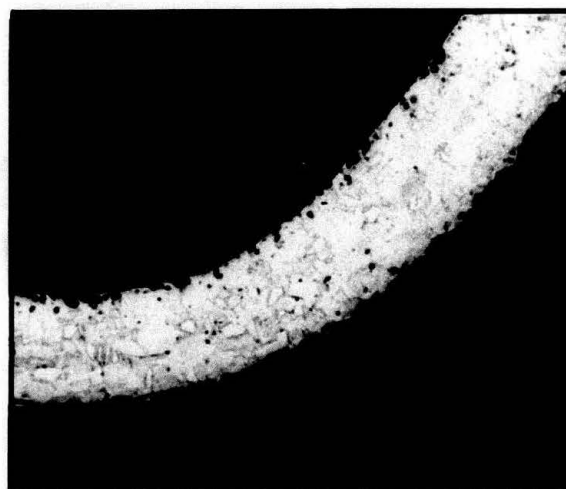
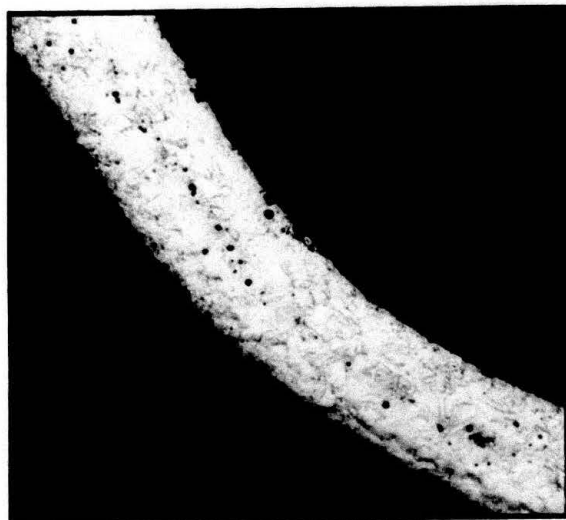
a. SAMPLES FORMED IN MANIFOLD
HOOP-TO-PLATE JUNCTION
(SEE FIGURE 2-22)

b. NDS 300, RUN
216, AS FORMED

c. NDS 300, RUN
216, BRAZE
CYCLED

Figure 2-26. Results of Plate-Forming Experiments of NDS Materials
(See Table 2-32)

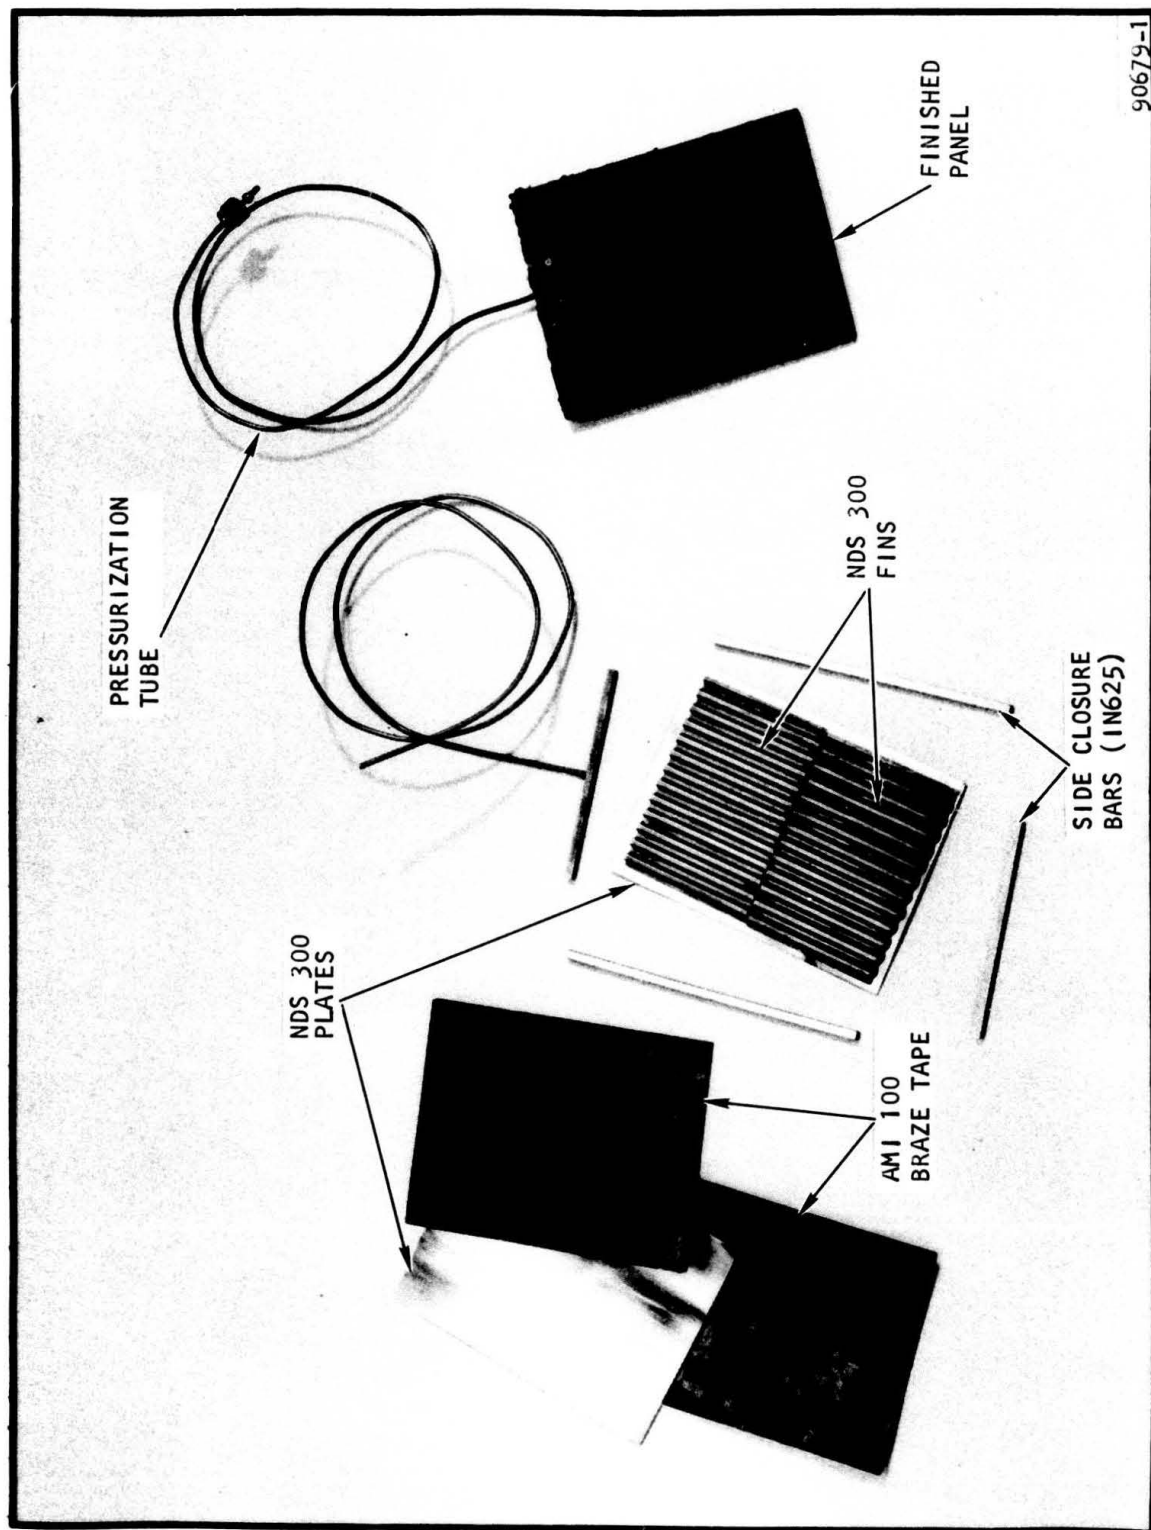
Figure 2-27. Assembly of Heat Exchanger Panels from NDS 300 Plates and Fins

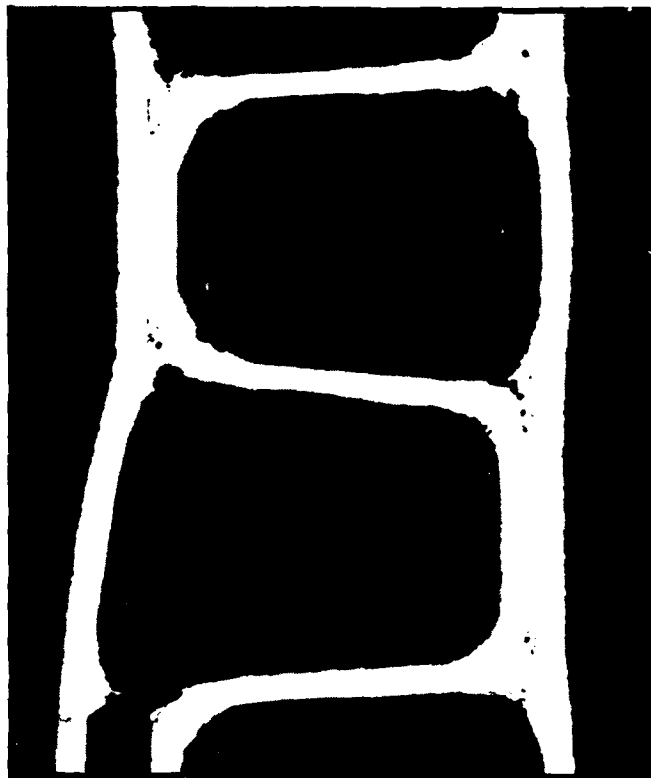
Figure 2-29. NDS 300 Panel Brazed with AMI 100 Filler Metal and Tested for 823.1 Hours at 16500F with 400 psig Argon

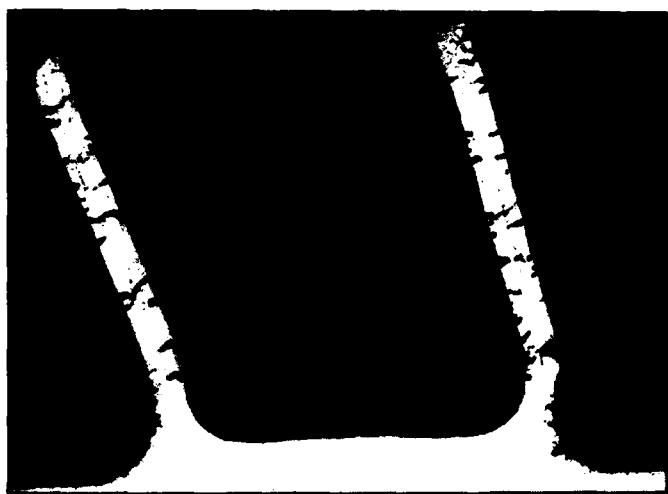
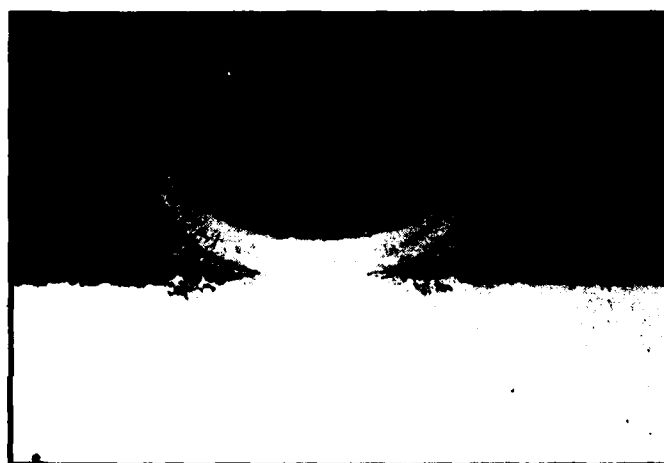
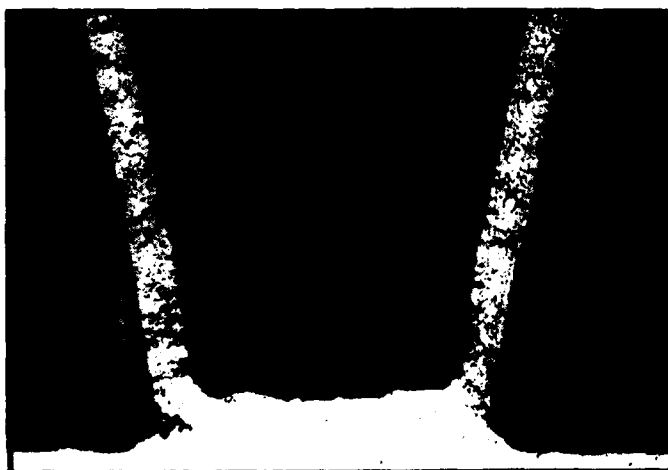
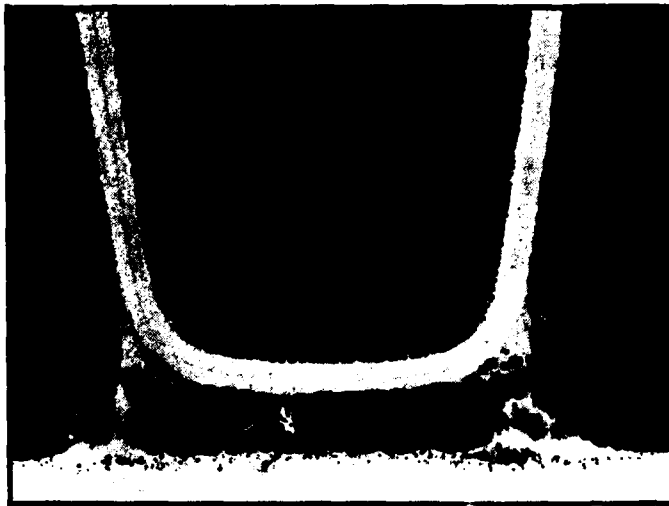
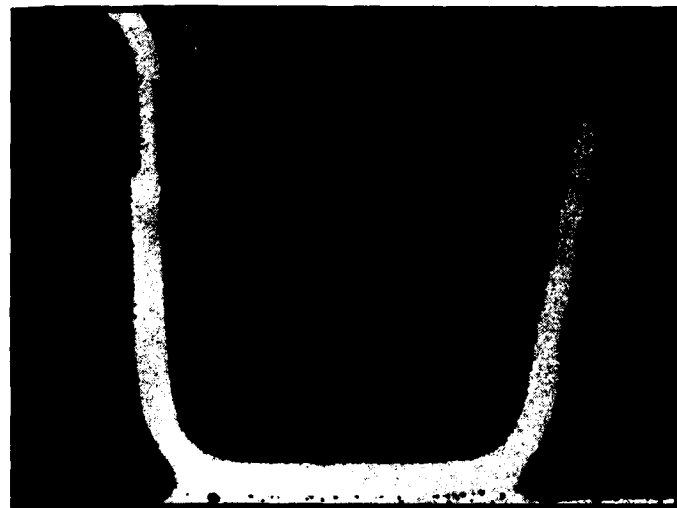
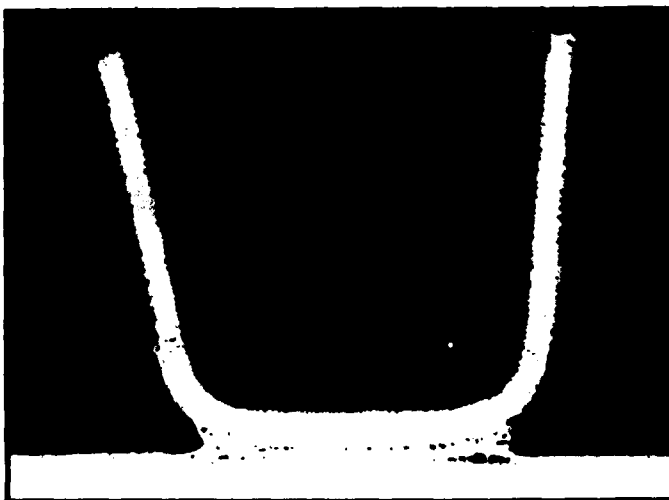
a. IN625 BARE;
FAILED 319 HR

b. NDS 300 BARE;
FAILED 1001 HR

c. IN625 COATED WITH
AMI 100 BRAZE;
TERMINATED 580 HR

Figure 2-32. Cross Sections of Stud-Fin Specimens, Comparing IN625 to NDS 300 after Stress Rupture Testing at 1800°F--Item (f) was at 1725°F--Under a Fin Stress of 2 ksi for the Times Shown; (Magnification, 25X)

d. NDS 300 COATED WITH
AMI 100 BRAZE;
TERMINATED AT 1001 HR

e. NDS 300 CHROMIZED;
FAILED 168 HR

f. NDS 300 CHROMIZED;
FAILED 1134 HR
(1725°F TEST)
